ExxonMobil's Toxic Torrance Refinery Failure, 2015

ChE333T

Spring 2019

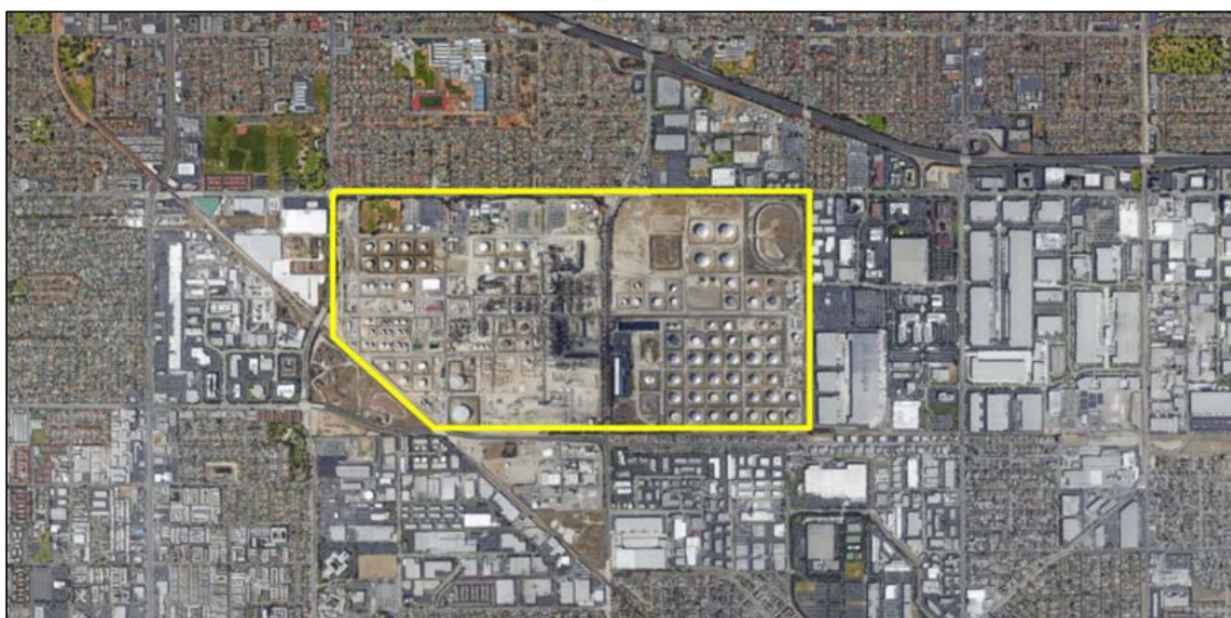
Figure 1. ExxonMobil's Torrance refinery is surrounded by a large community (CSB, 2017, p.9).

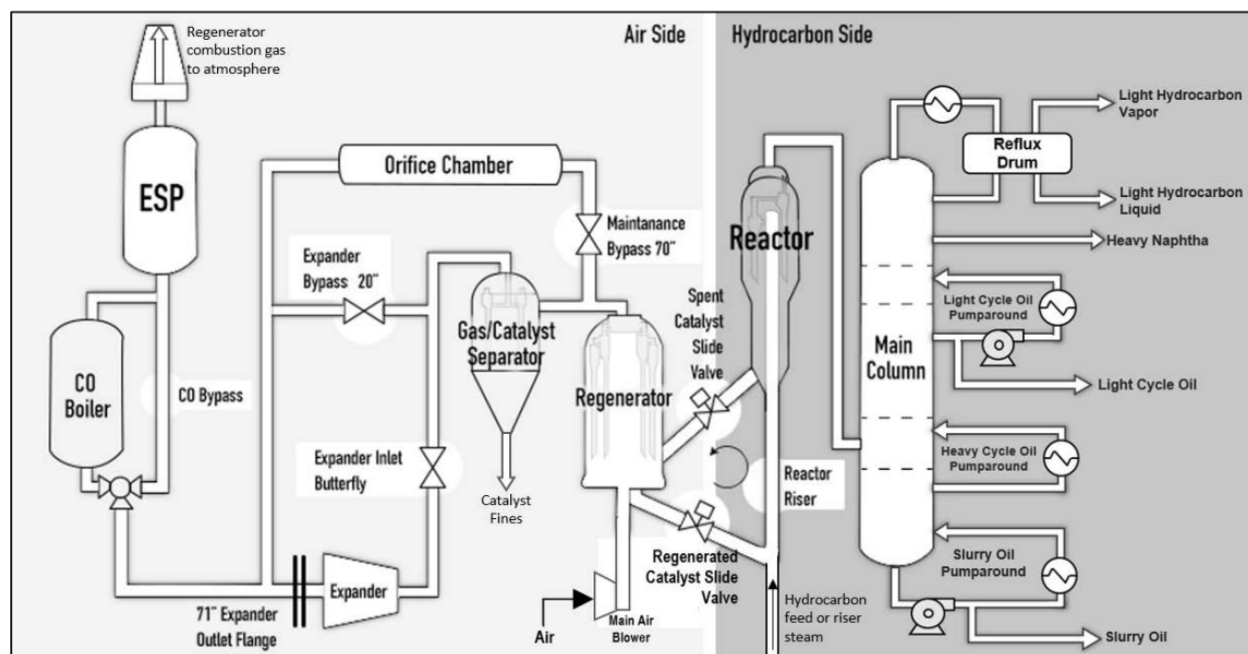
The Torrance refinery explosion occurred in the fluid catalytic cracking unit (FCC). The FCC unit breaks or “cracks” higher boiling point hydrocarbon molecules into smaller molecules, which is necessary for hydrocarbons to be used for fuel (CSB, 2017, p.10). At the end of the process, the FCC produces mainly light hydrocarbons and heavy naphtha, which are then further processed into gasoline (CSB, 2017, p.12). The FCC unit itself is divided by valves into two multicomponent sides: the air side and the hydrocarbon side as shown in Fig. 2 (CSB, 2017,

p.10). The hydrocarbon side contains the reactor, the main column, and a series of pumps. The air side contains the regenerator and the gas/catalyst separator, as well as the expander, boiler, and the electrostatic precipitator. Hydrocarbons should never enter the air side.

Figure 2. Outline of the Fluid Catalytic Cracking Unit, divided into the air side and the hydrocarbon side (CSB, 2017, p.10).

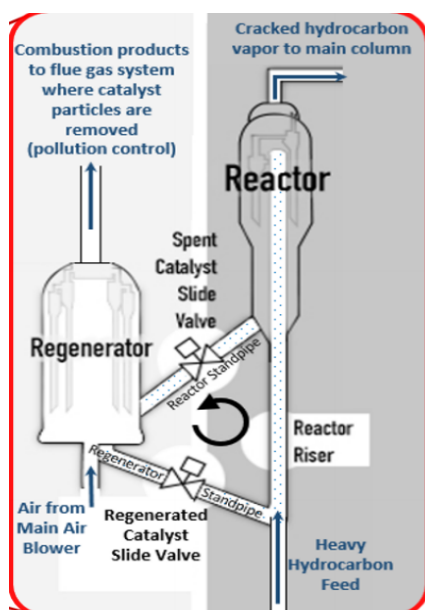
At the border between the two sides, a catalyst loop forms between the regenerator and reactor as shown in Fig. 3 (CSB, 2017, p.11). The small, spherical pellets of catalyst are aerated in this loop to ensure they flow throughout the whole system, rather than settling at the bottom of a unit (CSB, 2017, p.11). The heated and aerated catalyst leaves the regenerator and passes through the regenerated catalyst side valve (RCSV) into the reactor (CSB, 2017, p.12). After performing the reaction, the used or “spent” catalyst accumulates a thin coating of one of the solid byproducts from the reaction (CSB, 2017, p.12). Therefore, the spent catalyst must be sent through the spent catalyst side valve (SCSV) and back into the regenerator so the solid coating

Figure 3. Depiction of the catalyst loop between the regenerator and the reactor (CSB, 2017, p.11).

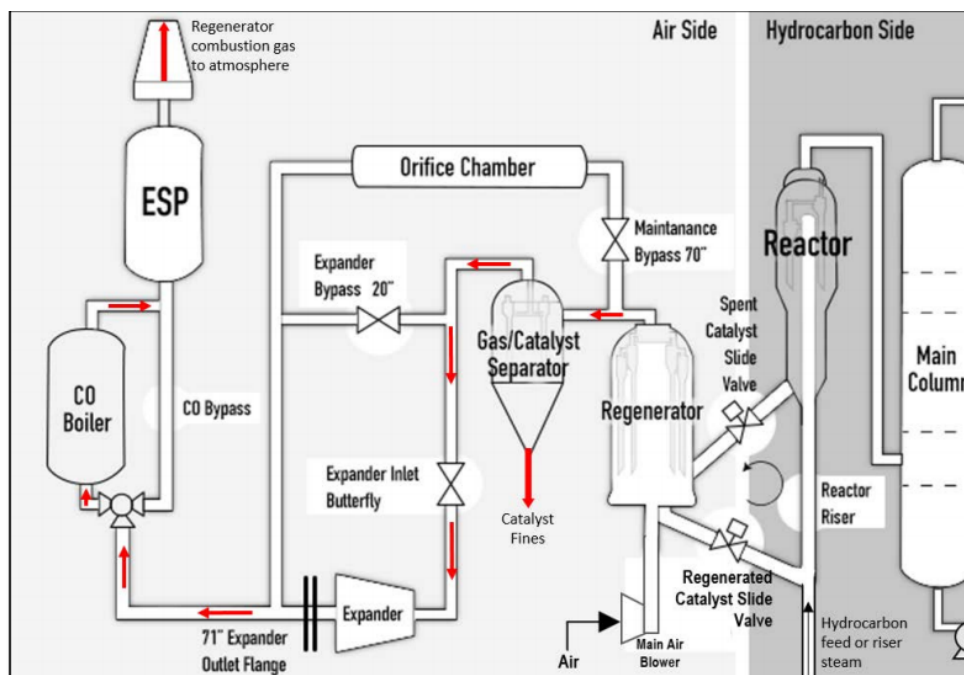
The combustion gas formed during the recycling of catalyst is treated within the FCC, as outlined in Fig. 4 (CSB, 2017, p.13). First, the gas is sent to the gas/catalyst separator which removes the majority of remaining catalytic dust in the gas (CSB, 2017, p.13). This cleaner gas is then sent through the expander, which uses the natural expansion of the gas to power the main air blower so catalyst can be aerated back in the catalyst loop (CSB, 2017, p.13). The combustion gas then enters the carbon monoxide boiler where leftover heat is removed. After removing leftover heat, the combustion gas is fed to the electrostatic precipitator (ESP) where spark-producing charged plates remove any remaining catalytic dust (CSB, 2017, p.13). The gas, now

Figure 4. Depiction of cleaning combustion gas process within the FCC unit (CSB, 2017, p.13).

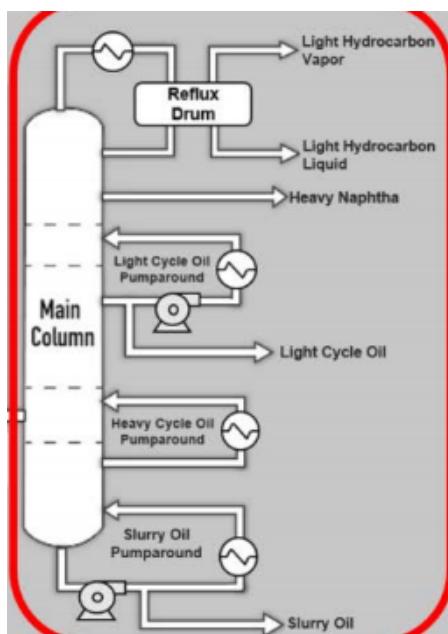
Returning to the other side of the catalyst loop, the catalyst and uncracked hydrocarbons remain in the reactor, while the “cracked” or broken down hydrocarbons leave the reactor so they can be further separated in the main column (CSB, 2017, p.12). In the main column, the hydrocarbon vapor is separated into its different forms by condensation as shown in Fig. 5 (CSB, 2017, p.12). Heat is removed from the vapor in the column by pumping the vapor through pipes that surround other pieces of equipment within the FCC, transferring heat in the process. As the hydrocarbon vapor cools, it condenses into light hydrocarbons and heavy naphtha, cycle oil, and an oil slurry, the final products of the FCC process (CSB, 2017, p.12).

Figure 5. Depiction of the Main Column used to separate hydrocarbon vapor by condensation (CSB, 2017, p.12).
